Waterbury Reservoir Crossing (viewing approx. Mile 3.7-3.9) - Existing Conditions

Waterbury Reservoir Crossing (viewing approx. Mile 3.7-3.9) - Simulation of Proposed Upgrade

Waterbury Reservoir Crossing (viewing approx. Mile 3.7-3.9) - Simulation of Recommendation

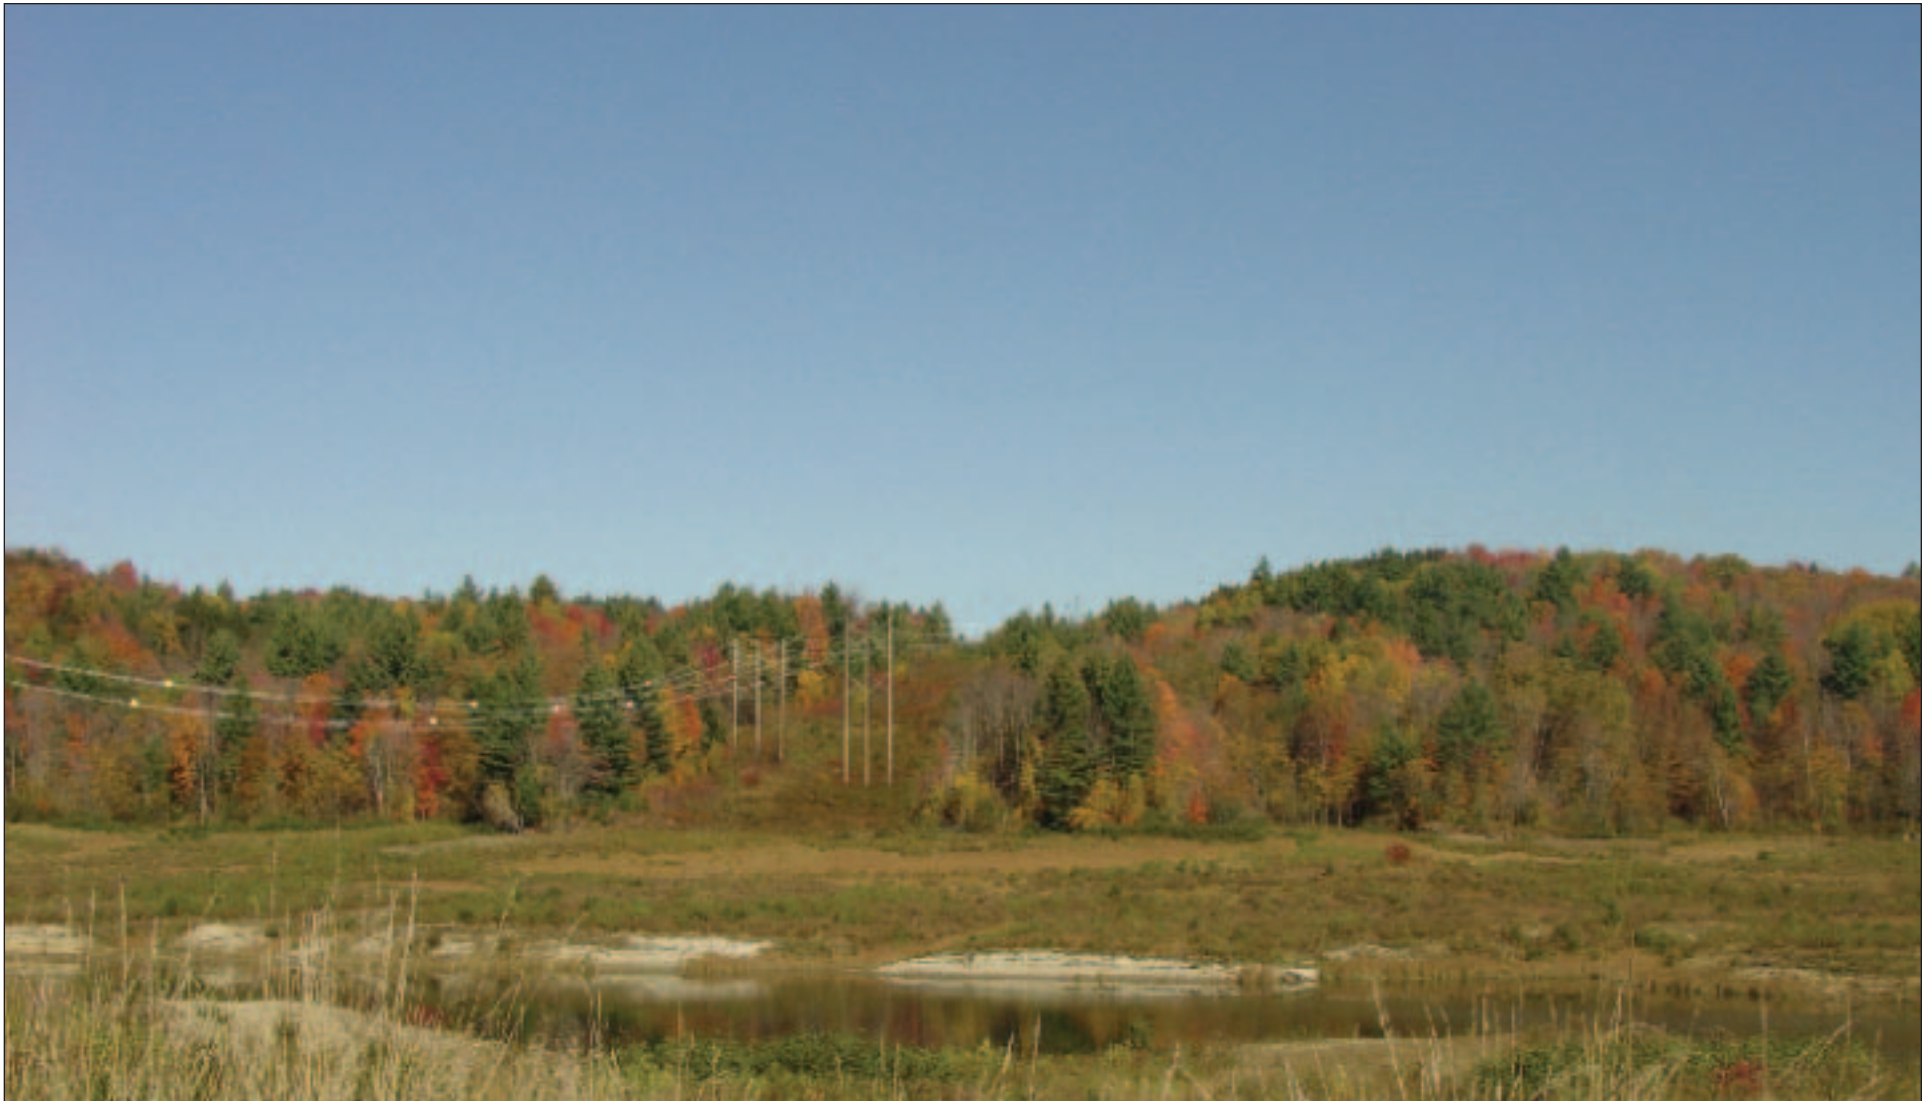
DPS-DR-10

This simulation shows the extent of clearing proposed for the additional 115kV structure as well as the angle structure beyond. VELCO is not certain at this time how many “marker balls” will be required on the conductors.

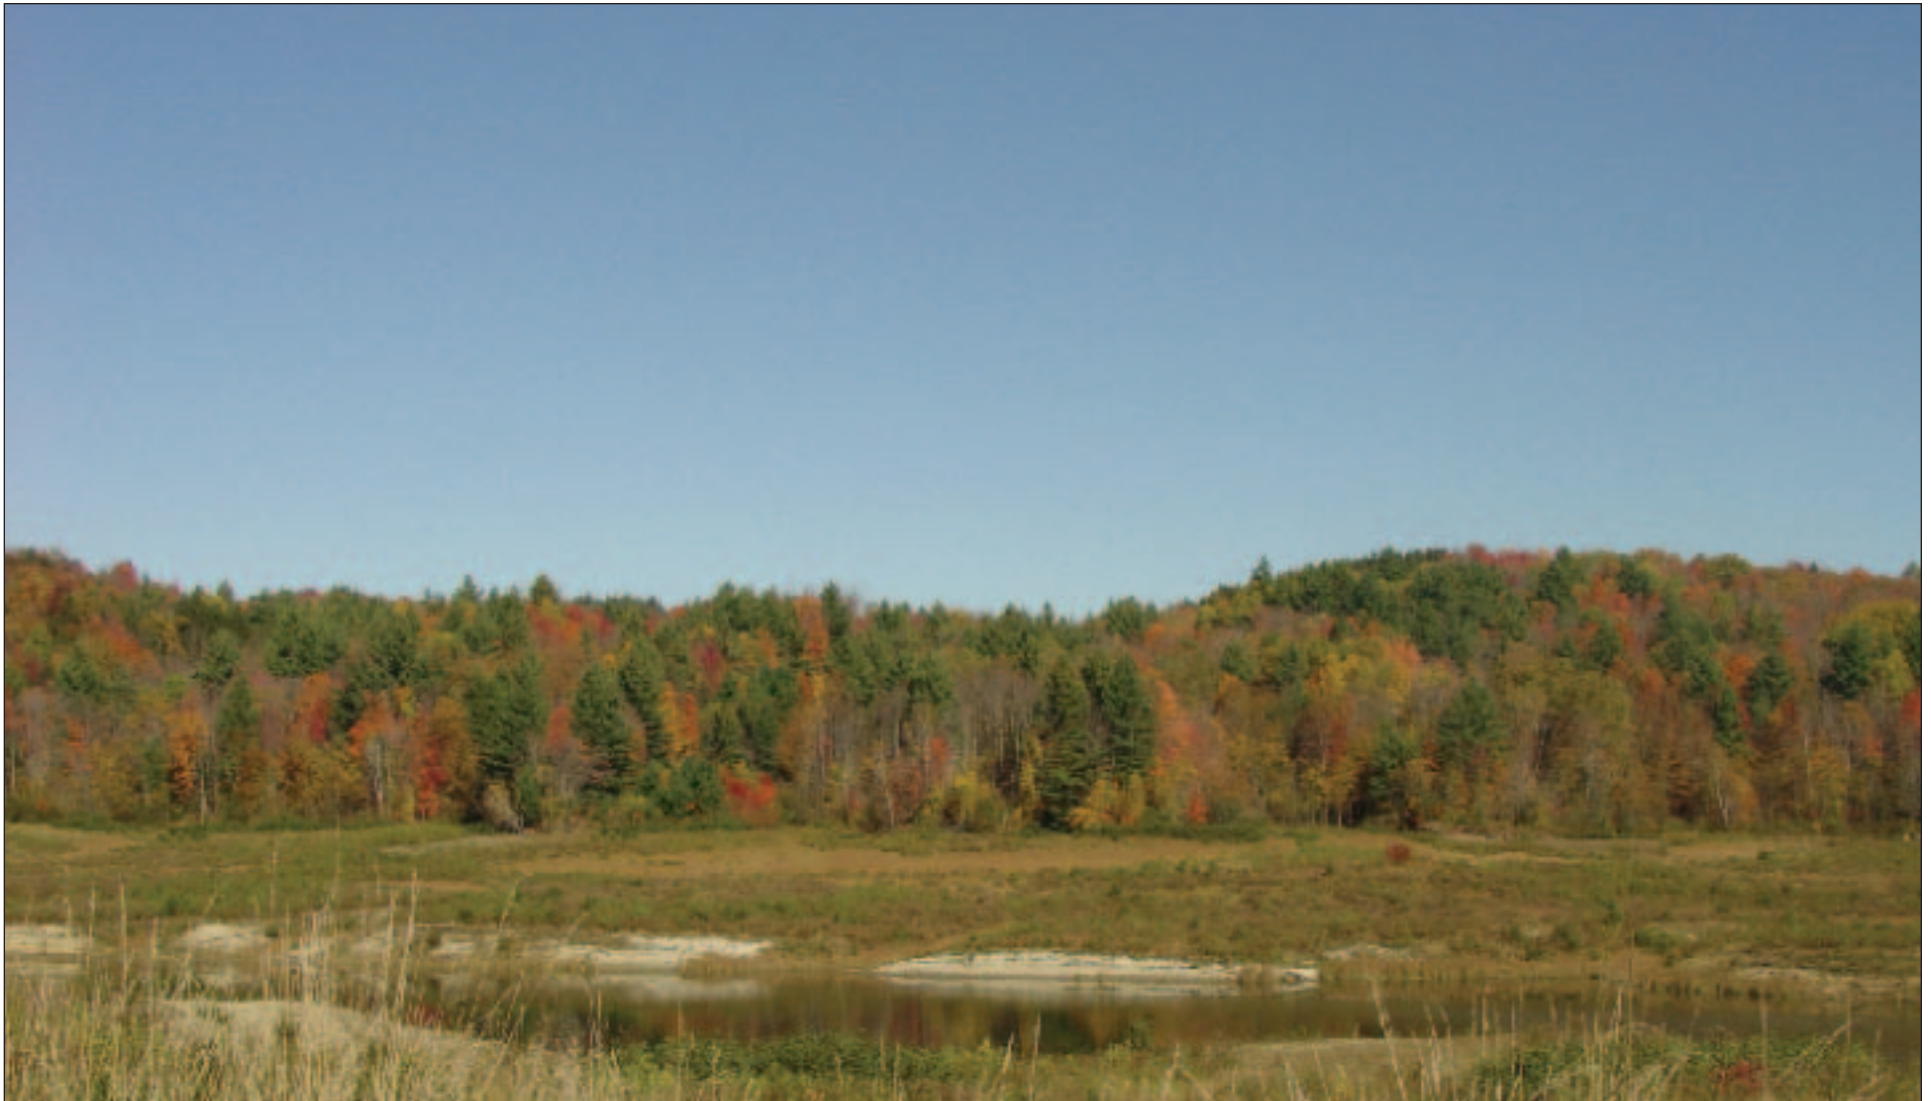
DPS-DR-11

Undergrounding of proposed lines will enhance views and retain the character of the landscape. With undergrounding, mitigation planting is recommended in existing corridor. This simulation shows the clearing in approximately 10 years, with a tree height of approximately 20 feet.

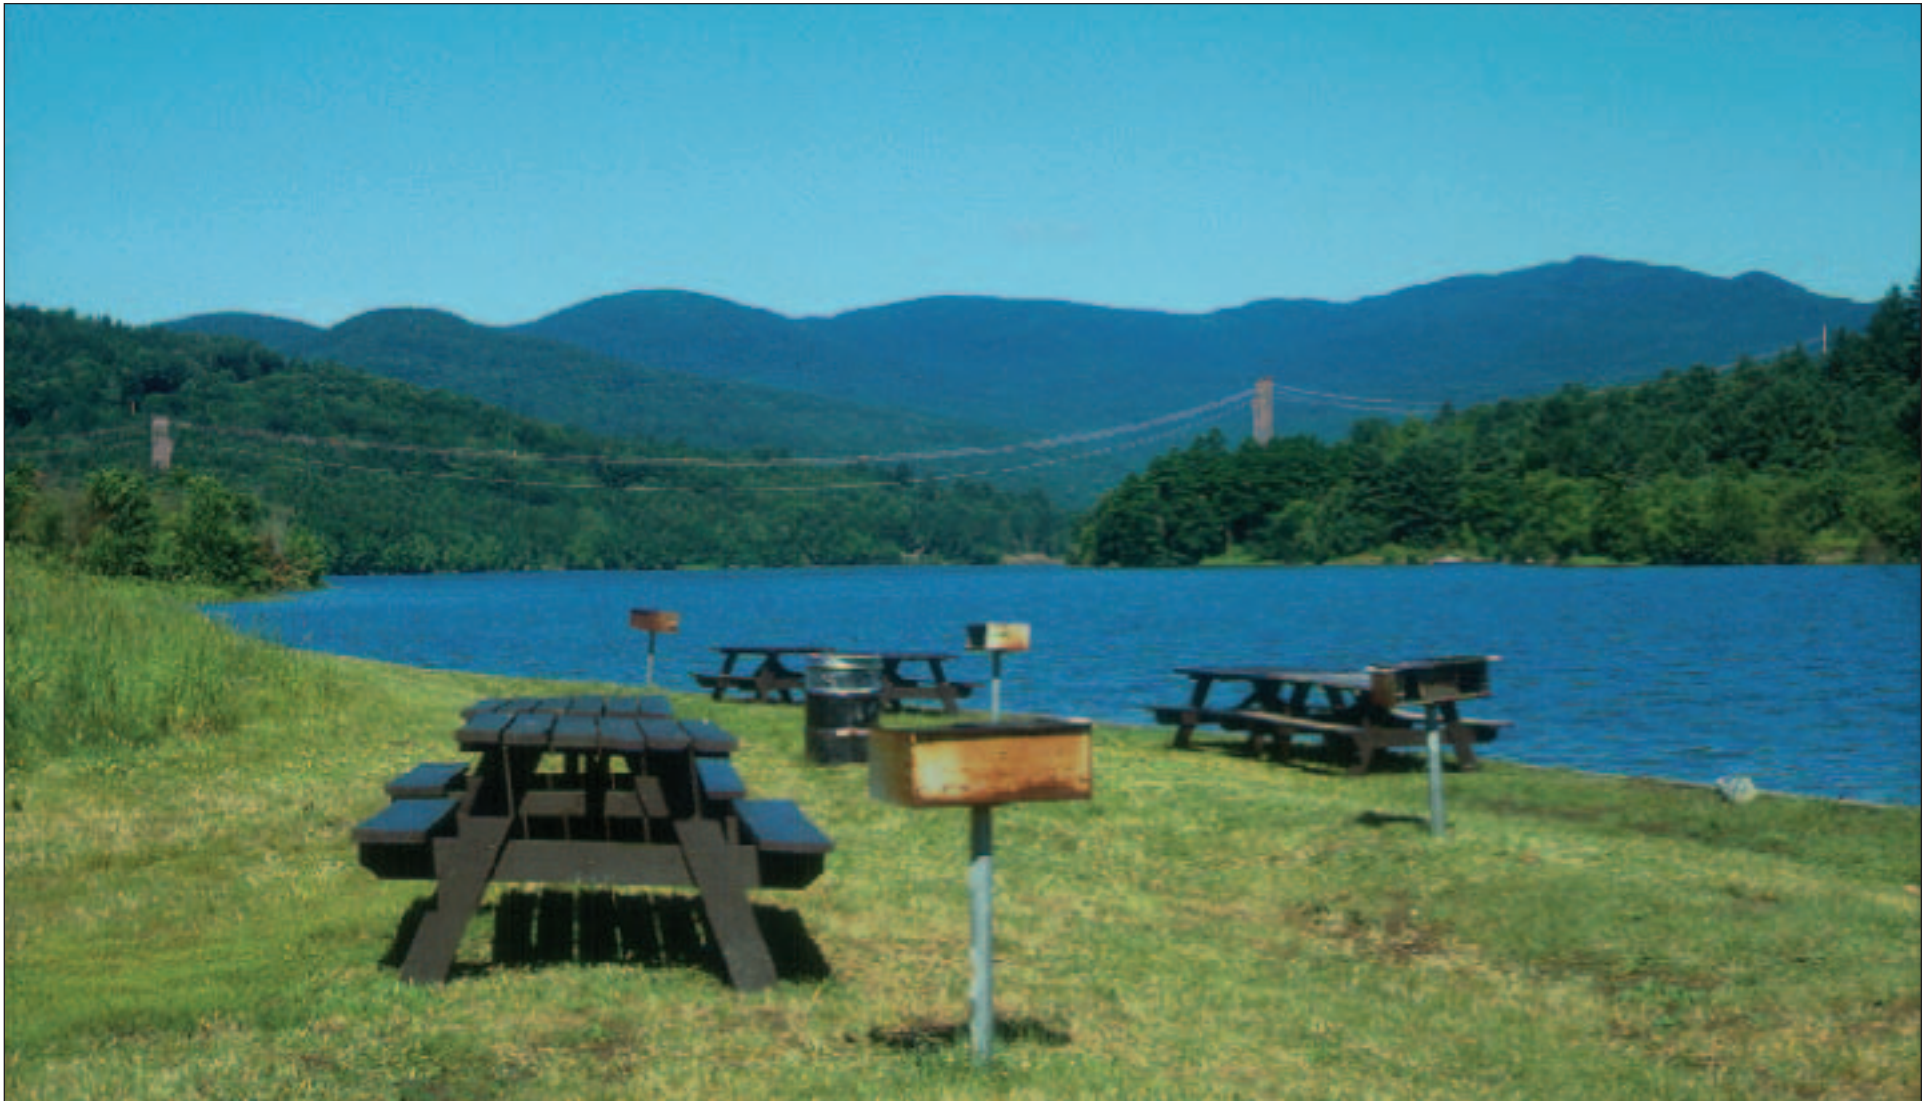
DPS-DR-13

Waterbury Reservoir Crossing (viewing approx. Mile 3.7-3.9) - Simulation of Proposed Upgrade

The measured heights of the 34.5 kV and new 115kV frames will cause them to be visible above the treeline to park users and boaters. The different sag lines of the conductors will also be noticeable and further draw attention to this discordant element.

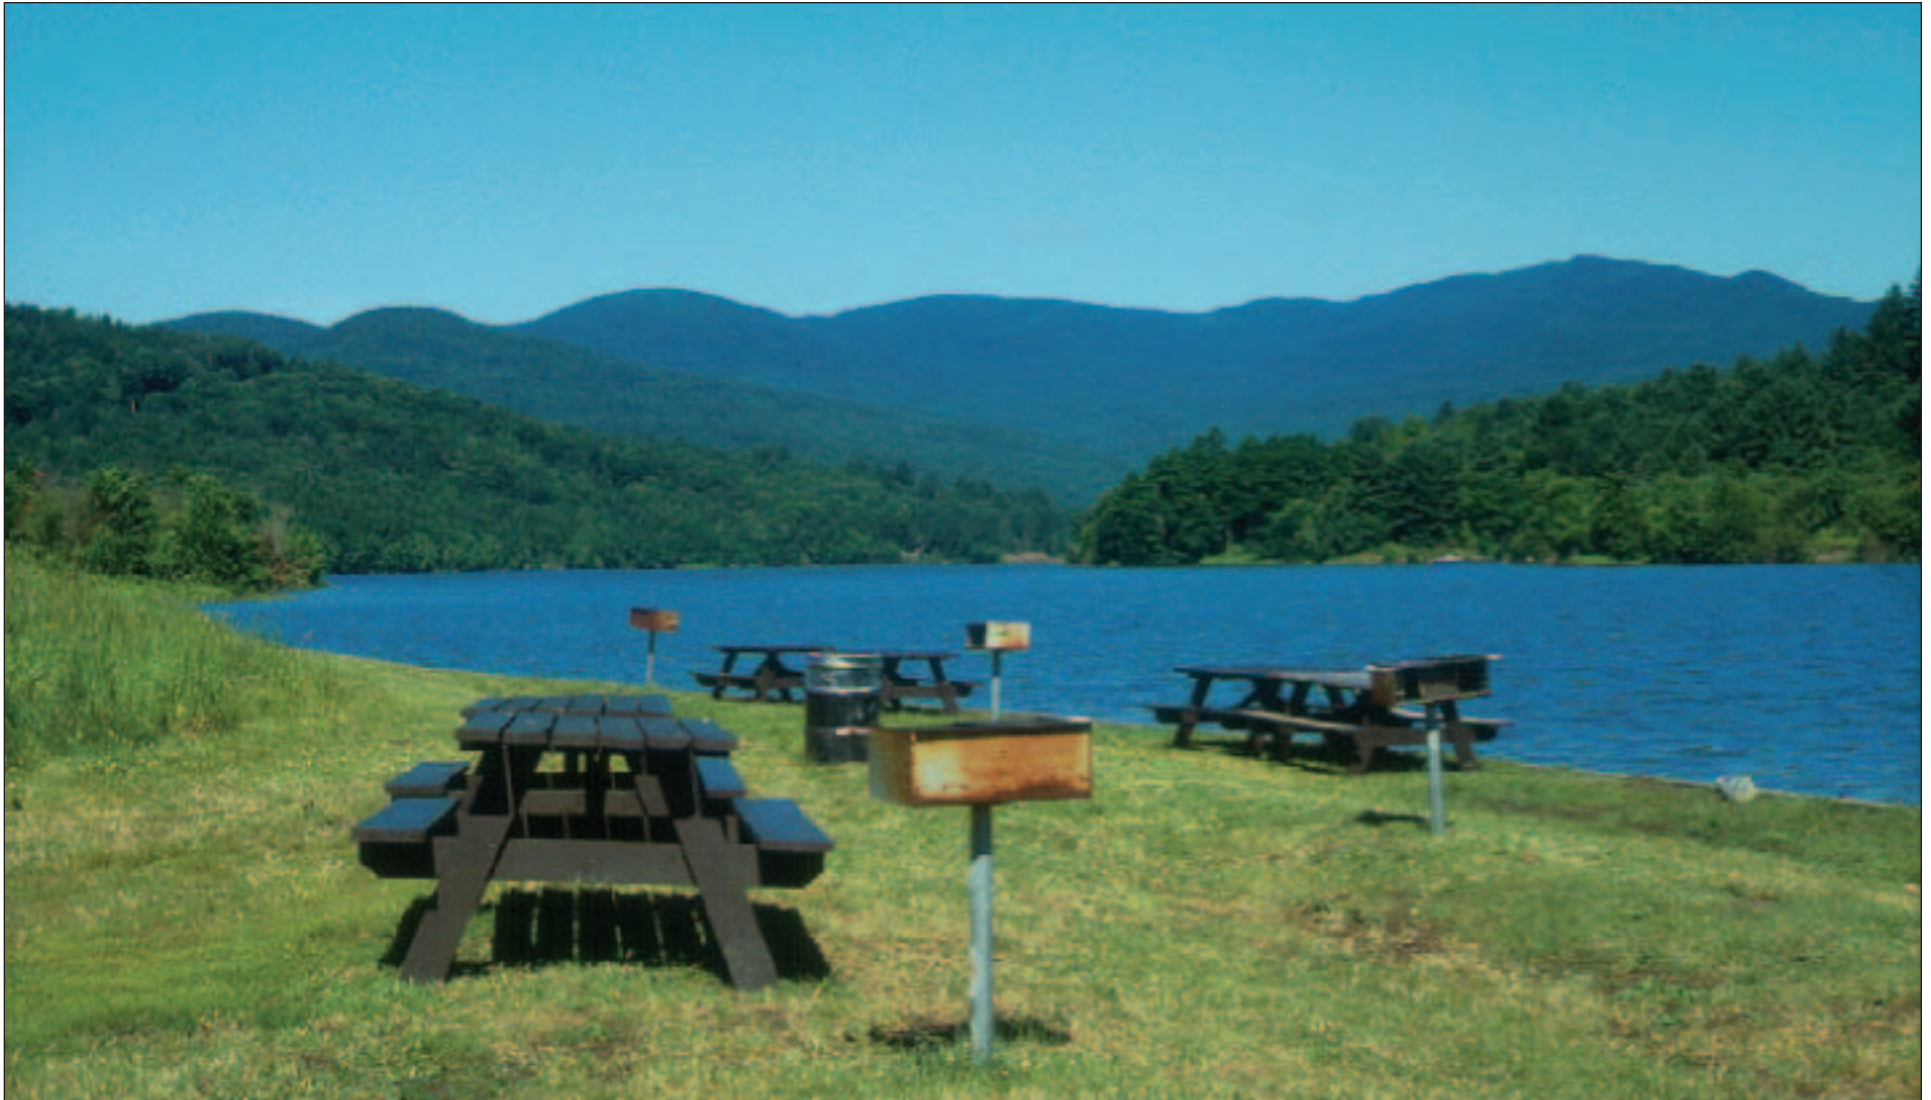
DPS-DR-14

Waterbury Reservoir Crossing (viewing approx. Mile 3.7-3.9) - Simulation of Recommendation

Undergrounding of proposed lines will enhance views and retain the character of the park.

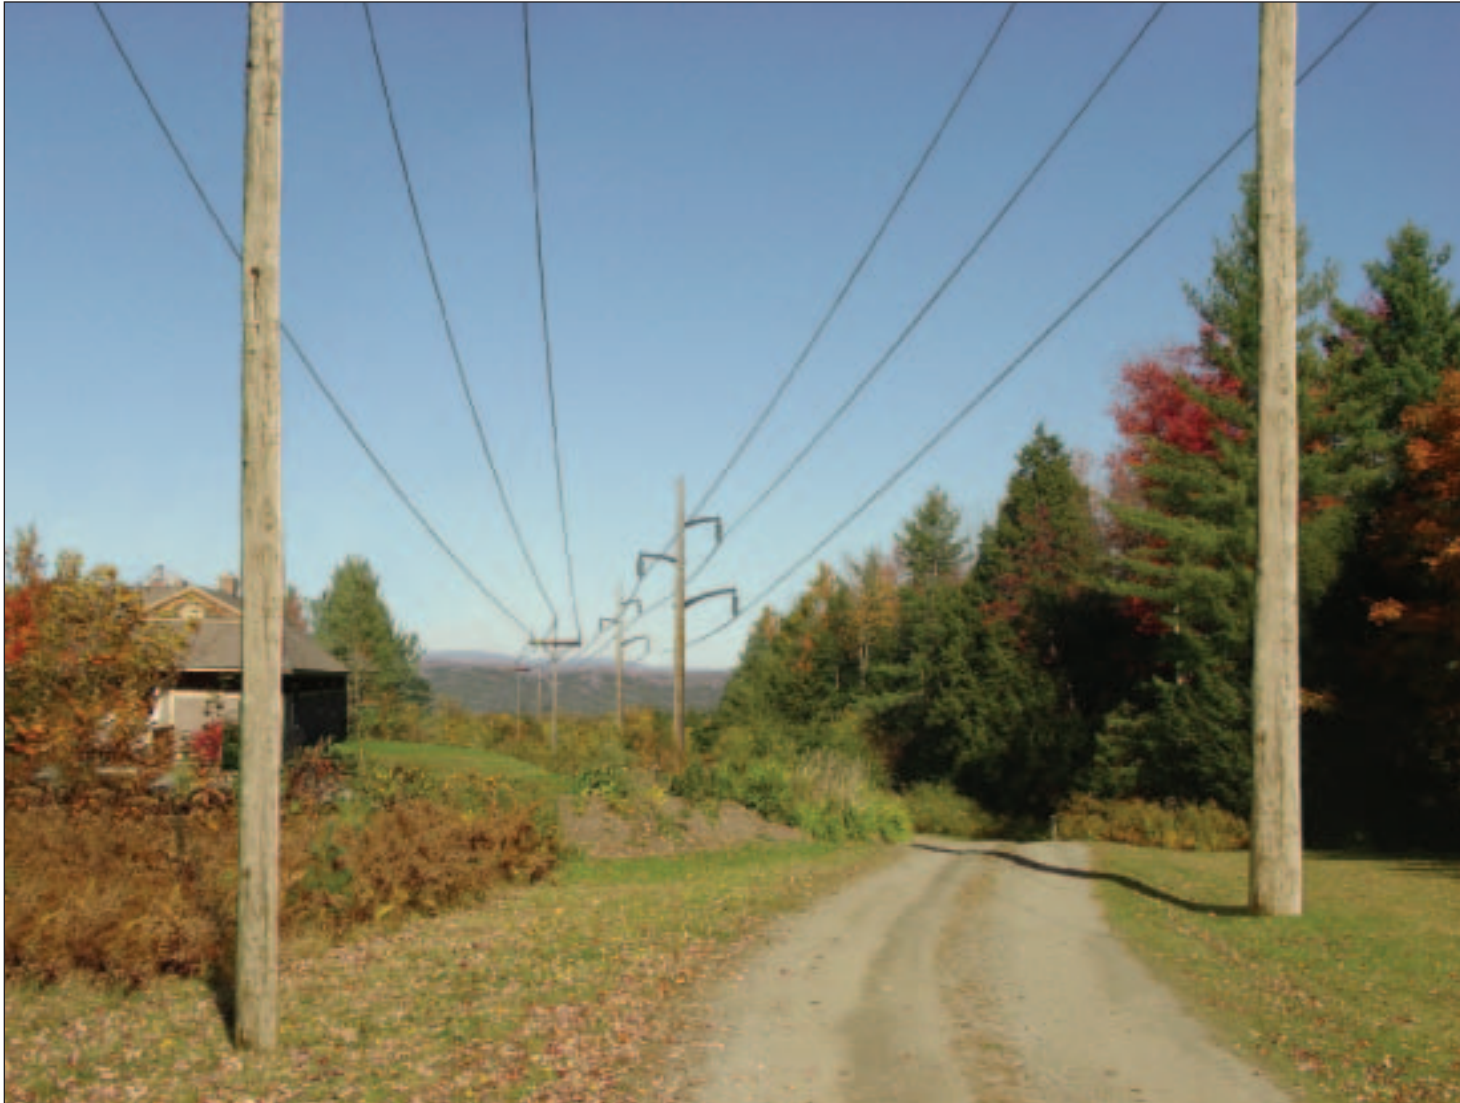
DPS-DR-16

Black Bear Run (Mile 6.9) - Simulation of Proposed Upgrade

This simulation shows the proposed rebuild of the 34.5kV line, the additional 115kV line, and the projected clearing of the 100' R.O.W.
